# **OPTIWOOD**

## **Improving the Performance and Efficiency of Biomass Boilers**

**Report– Greenhouse-Retail Pilot Site**

# Optiwood Biomass Boiler Monitoring and Assessment of Site Operating Efficiencies and Recommendations

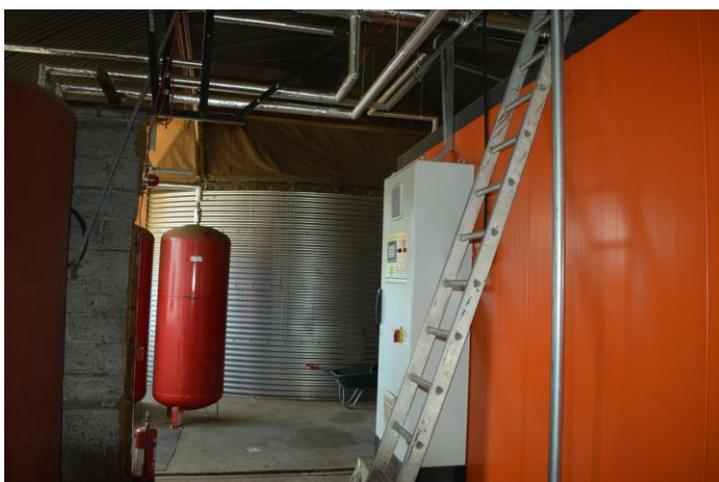
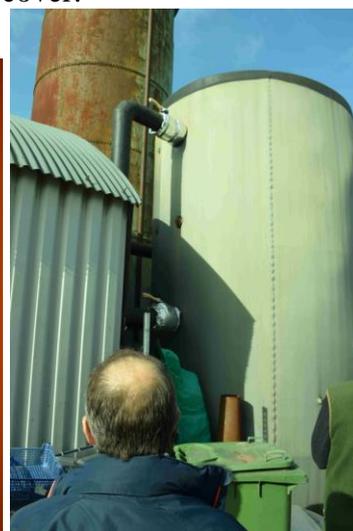
**990kW Heizomatt boiler (orange) with fuel silo to left Outdoor Buffer Tank**

The buffer tank set up is shown above. The tank has no stratification, just a simple flow and return set of connectors. The insulation material is a zipped up insulation jacket, designed for internal rather than external use. Due to a combination of ultra-violet light and rain, the insulation jacket is showing signs of significant deterioration (notice the bulges as the material is sagging). It is not providing decent thermal insulation to the tank and heat losses are likely to be high in winter.

- Review the buffer tank insulation issue. We recommend that proper insulation be applied (e.g. spray-on foam) to replace the deteriorating current insulation jacket, and that the tank have a simple structure built around it to keep it away from the weather. Discussion took place with the client on this but as of January 2020 no final decision had been made to action the work

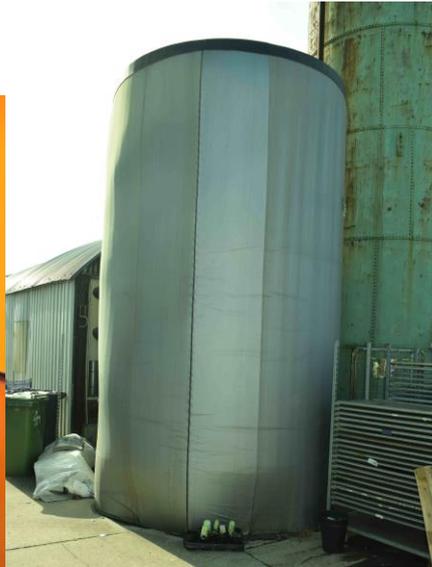
**External Buffer tank**

This is a very basic biomass boiler set up to run at temperatures that work for the greenhouses and retail-public area. The system essentially puts out heat, using the buffer tank mainly as a very temporary heat store and without any stratification. The buffer tank is located outside with an indoor specification insulation jacket so higher heat losses can be expected from water ingress, lower than expected ambient temperatures, and in due course sun/weather damage to the fabric covering.

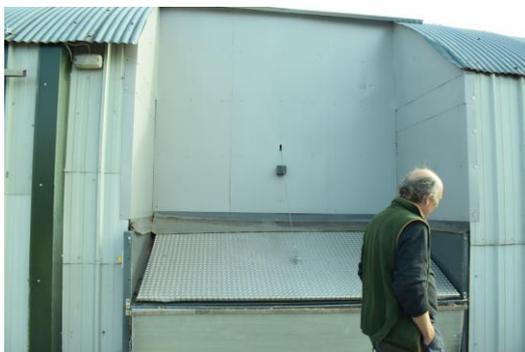
**Hatch for Fuel Delivery Access**

An above ground round silo wood chip store is adjacent to the boiler house with a simple rotary outfeeder and spring agitators to feed the fuel to two off transport augers before entering the biomass boiler. An access flap to the silo is sometimes left open allowing rain-snow to enter
